POST-CONSTRUCTION WILDLIFE MONITORING
AT THE ATLANTIC CITY UTILITIES AUTHORITY-
JERSEY ATLANTIC WIND POWER FACILITY

PERIODIC REPORT COVERING WORK CONDUCTED
BETWEEN 20 JULY AND 31 DECEMBER 2007

18 February 2008

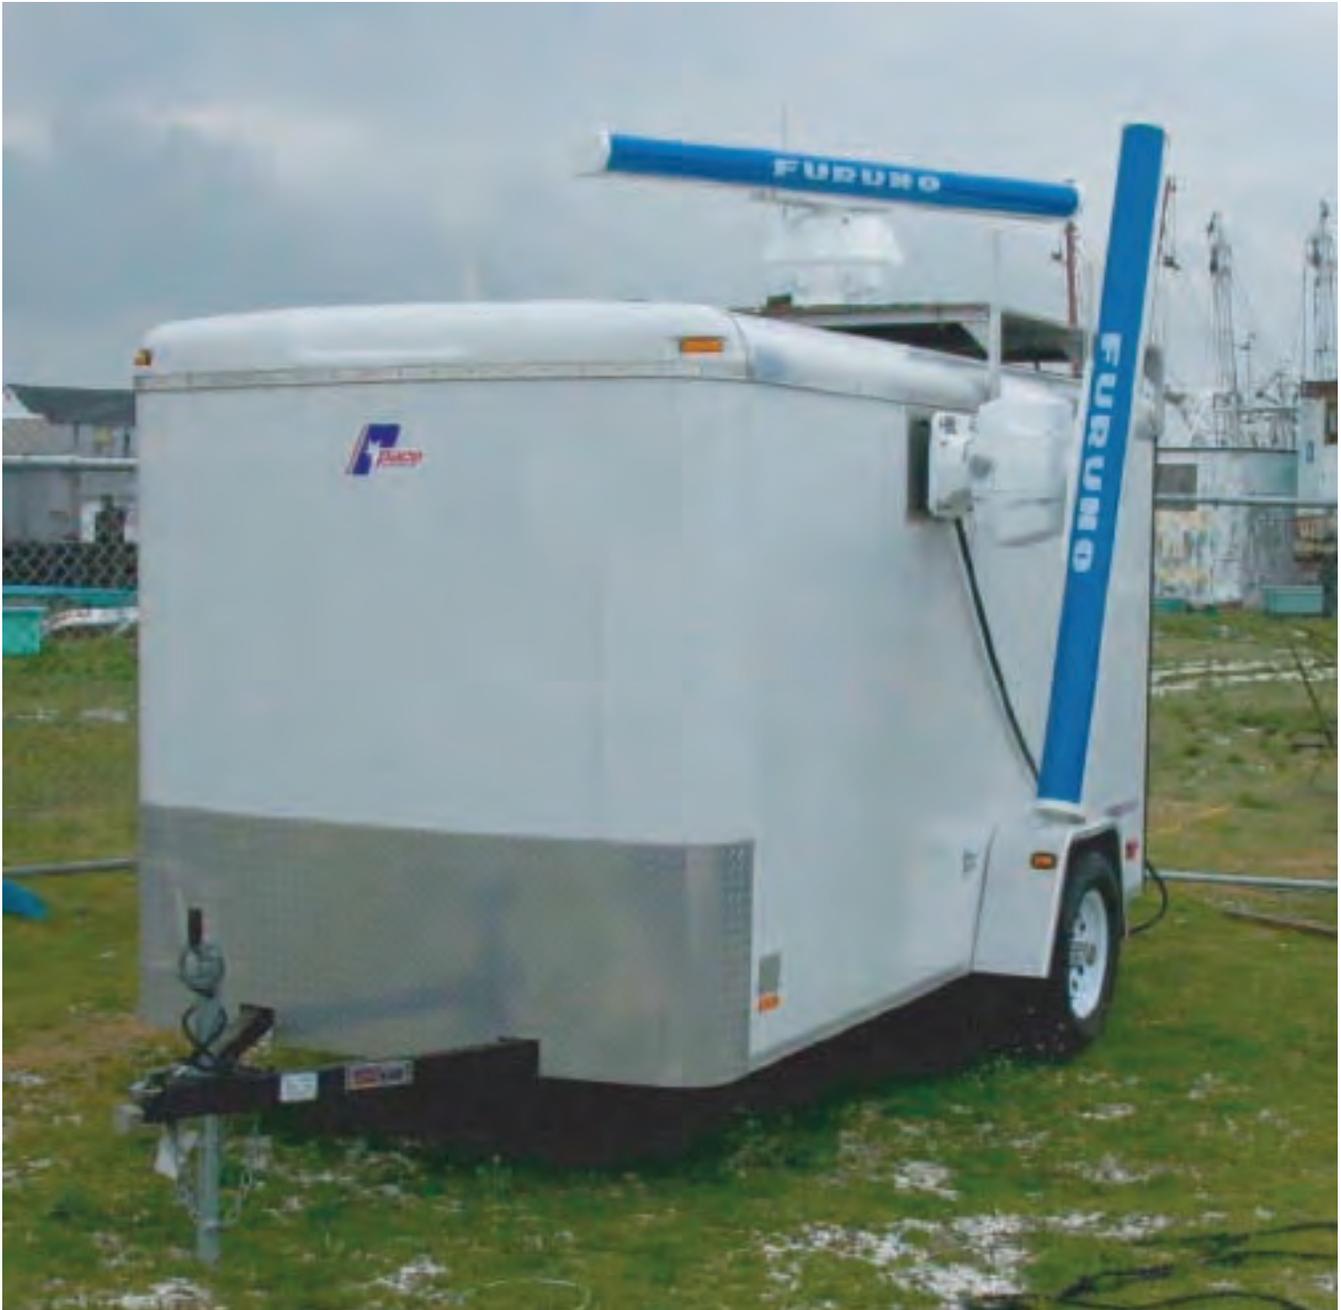
Figure 1. Dual radar system with horizontally and vertically oriented antennas that operate simultaneously. This system allows for data collection on passage (horizontal and vertical), altitude (vertical) and flight direction (horizontal).

1. On 20 July we began four days of testing to identify the best location and orientation for the dual marine radar system at the ACUA site.
 - a. Despite extensive testing of different locations and orientations we were unable to eliminate ground clutter and interference resulting from the turbines and other reflective structures on the ACUA site (Figure 7).
 - b. Tests resulted in locating the radar system at 39°23.02'N, 74°26.93'W, in the NW sector of the study site, near Turbine #2 (Figure 1). We believe this location is

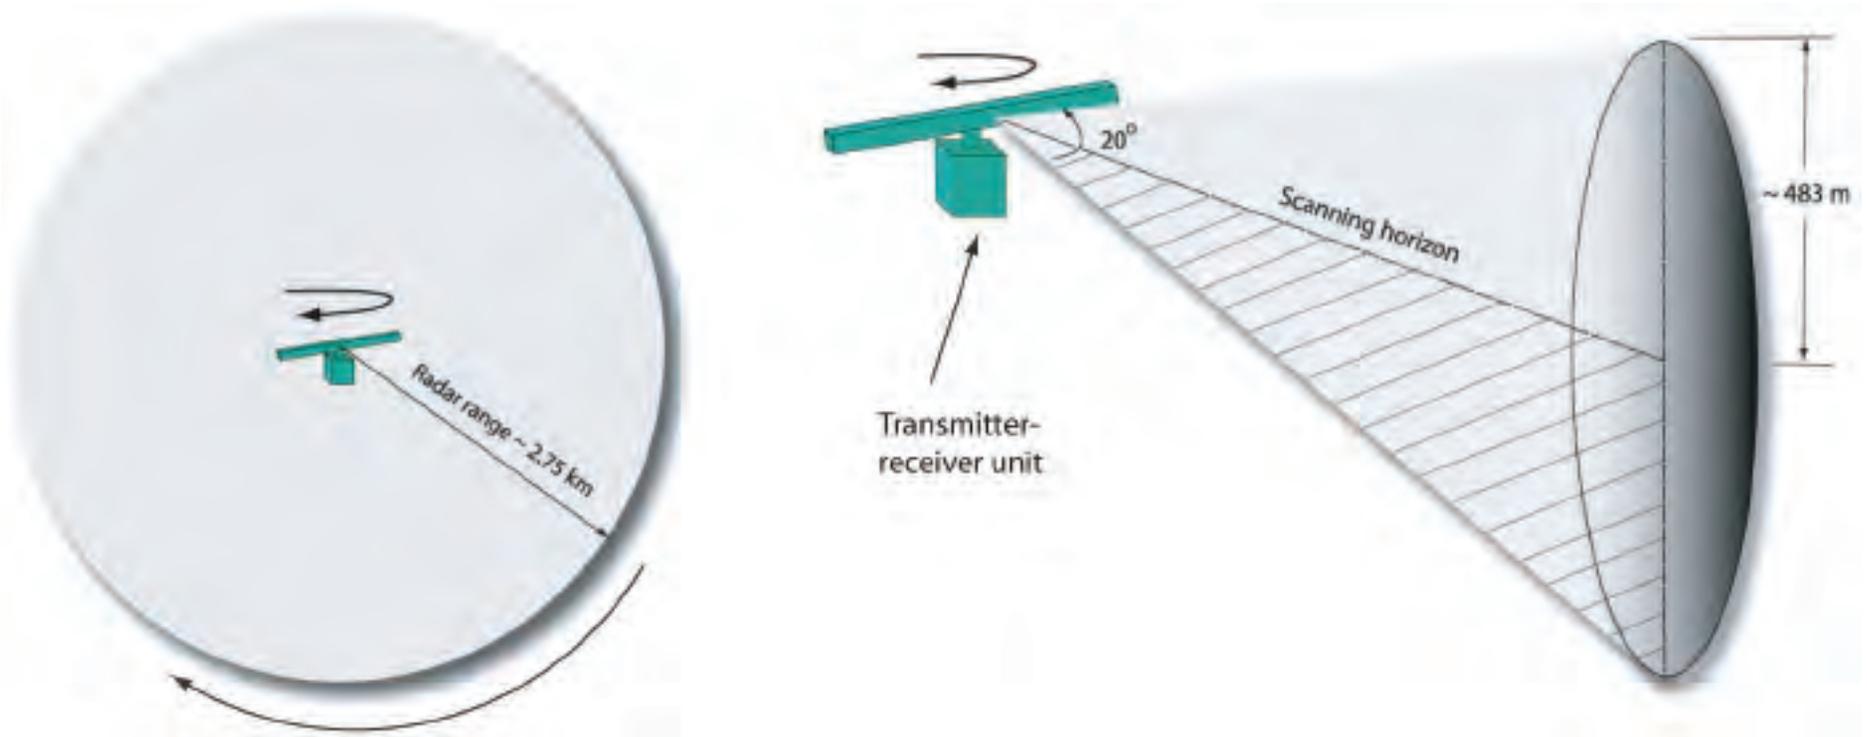
Figure 2. Graphical depiction of scanning operation of horizontally-oriented radar. In this orientation, the antenna rotates in a plane parallel to the ground resulting in a 360° scan with a that samples 10° above and below the scanning horizon. With the radar's range set to 1 nautical mile (1.85 km, 6076 ft) which is the effective detection range for small passerines with 25 kW radar) it samples up to 483 m arl (above radar level) and ~4.0 km³ of air space. Data collected in "horizontal" scanning mode can be used to estimate (1) target flight direction and speed and (2) target passage magnitude.

One radar unit operated with the antenna rotating in the horizontal plane, describing a 360° arc every 2.5 seconds. Data collected in this mode provided target density (i.e., targets/unit volume) and passage rate (targets/km/hr) estimates (Figure 2). The second radar's antenna rotated in the vertical plane. This is accomplished by mounting the antenna turning unit perpendicular to the ground (Figure 1). In this mode, the radar monitors the altitudinal distribution of targets and passage density/rates. The antenna sweeps from the eastern to the western horizons, describing a

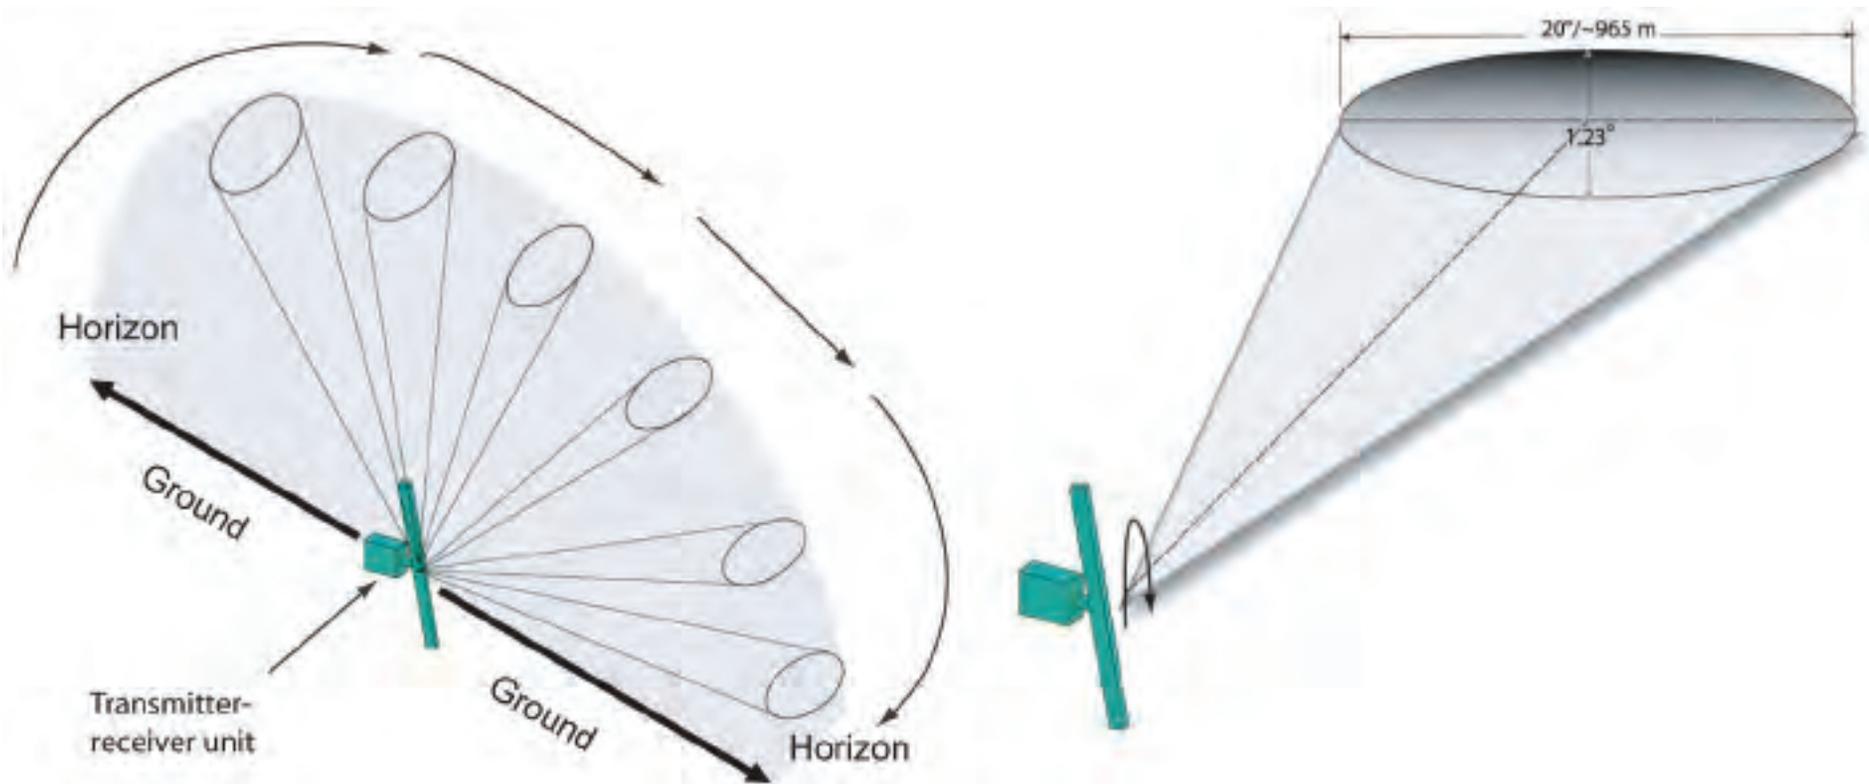
Figure 3. Graphical depiction of scanning operation of vertically-oriented radar. In this orientation, the transmitter-receiver unit is mounted perpendicular to the ground so that the radar antenna's rotation results in a 180°, horizon-to-horizon scan (radar does not transmit when antenna is oriented groundward). When the radar's range is set to 0.75 nm (1.4 km, 4557 ft) it samples ~0.98 km³ of air space. Data collected in "vertical" scanning mode can be used to estimate (1) target altitude and (2) target passage magnitude.

180° arc above radar level (arl), 20° wide (Figure 3). To avoid spurious target propagation, the radar does not transmit when the antenna is pointing toward the ground. We anticipated that the radar's orientation (i.e., facing northward, antenna sweeping approximately east to west) would maximize the number of target detections along the predominantly north/south axis of bird migration.

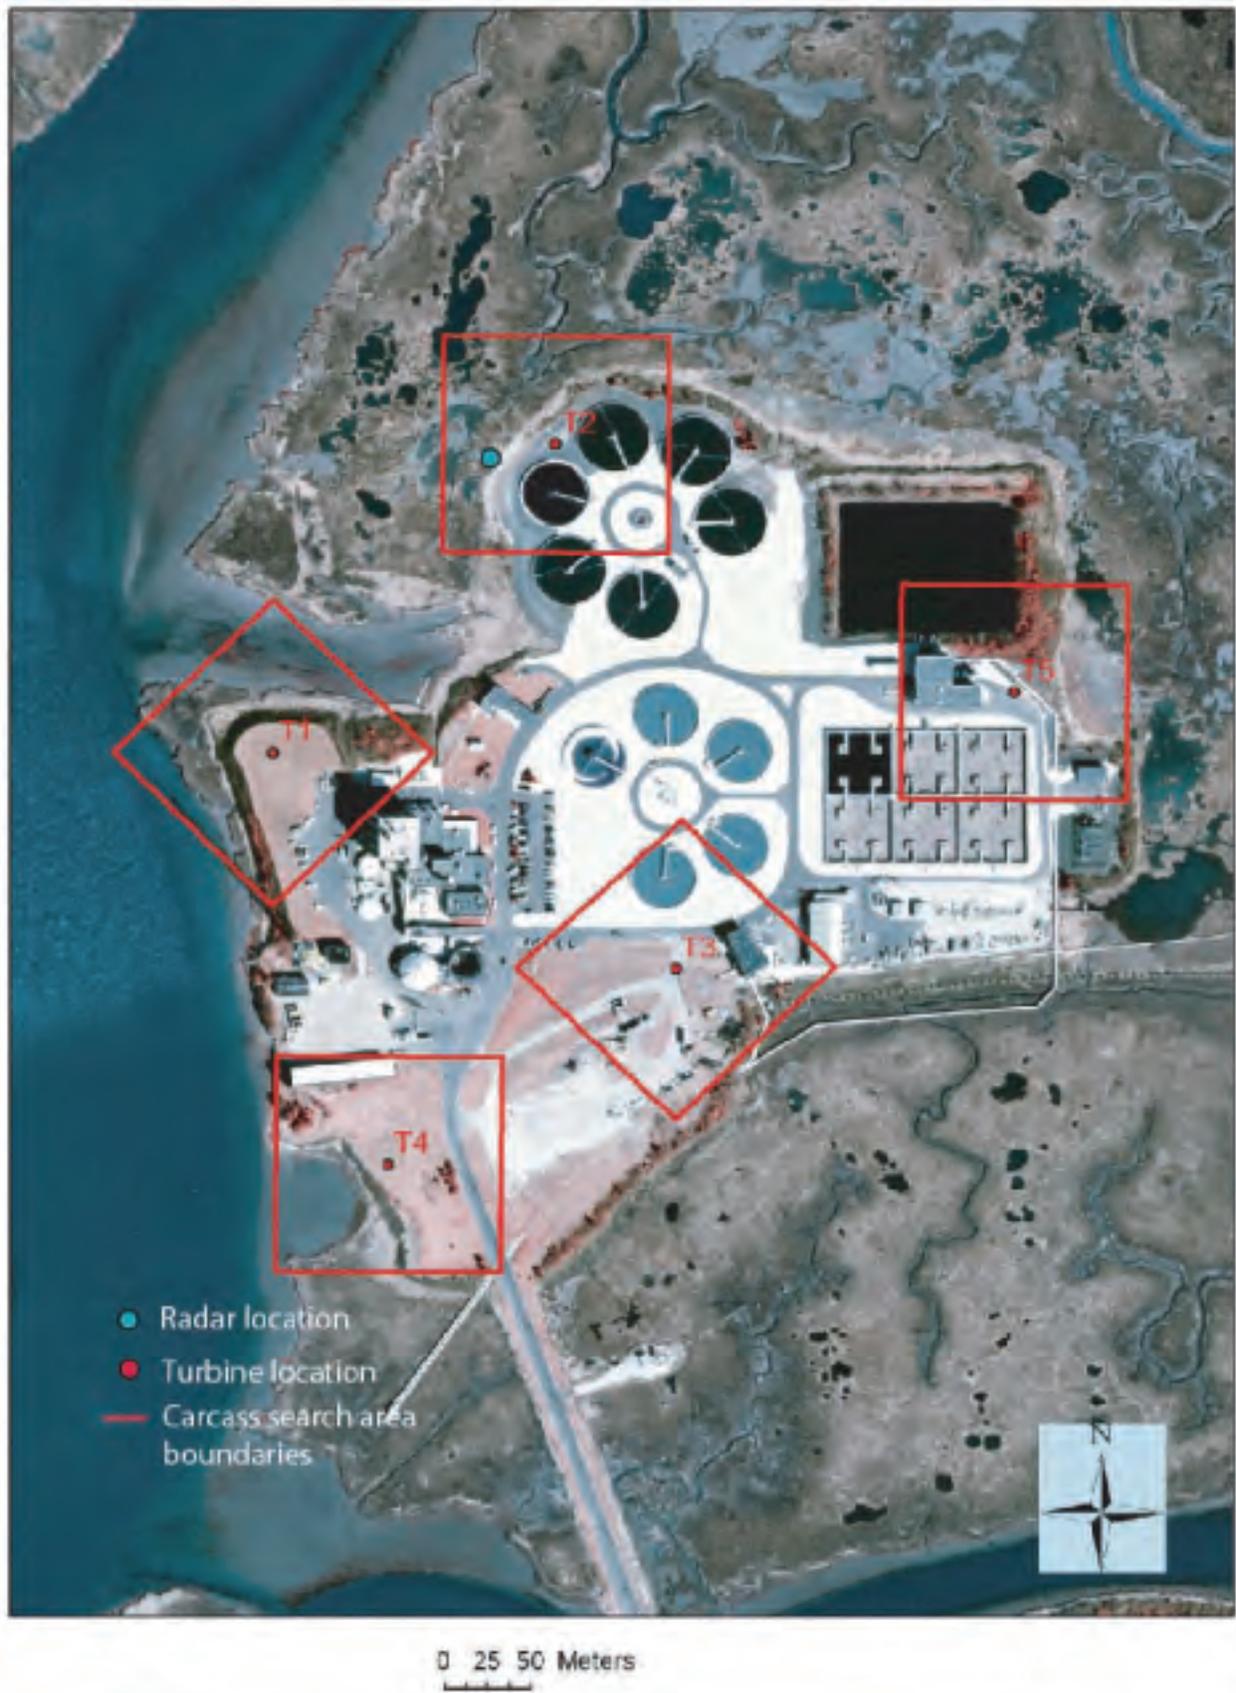
Figure 4. Atlantic City Utilities Authority (ACUA) study site showing the location of five wind turbines, carcass search area boundaries and location of dual marine radar system. Turbine (T) locations are numbered 1-5.

We conducted systematic searches on the ACUA facility for birds and bats that apparently collided with on-site wind turbines. Searches were conducted around each turbine site (Figure 4) by a single, trained NJAS staff person and consisted of walking in parallel transects 5 m apart within an overall search area of 130 m x 120 m (i.e., 15,600 m²/turbine) centered on each turbine tower (Figure 5). Search areas and transects were laid out in a geographic information system (GIS) and marked on site using a global positioning system (GPS) and rangefinder. Low lying marsh areas within a turbine's search area were not surveyed because tidal inundation regularly prevented access to these sections (Figure 6). To some extent this was the case at all turbine sites except at turbine #3 (Figure 6). If a building fell within the search area, rooftops were surveyed when accessible. Clarifying and mixing ponds, and other water bodies were also surveyed using walkways, gangways and dikes to gain access. Collision incident estimates will be corrected for the proportion of the total area around each turbine that was searched.

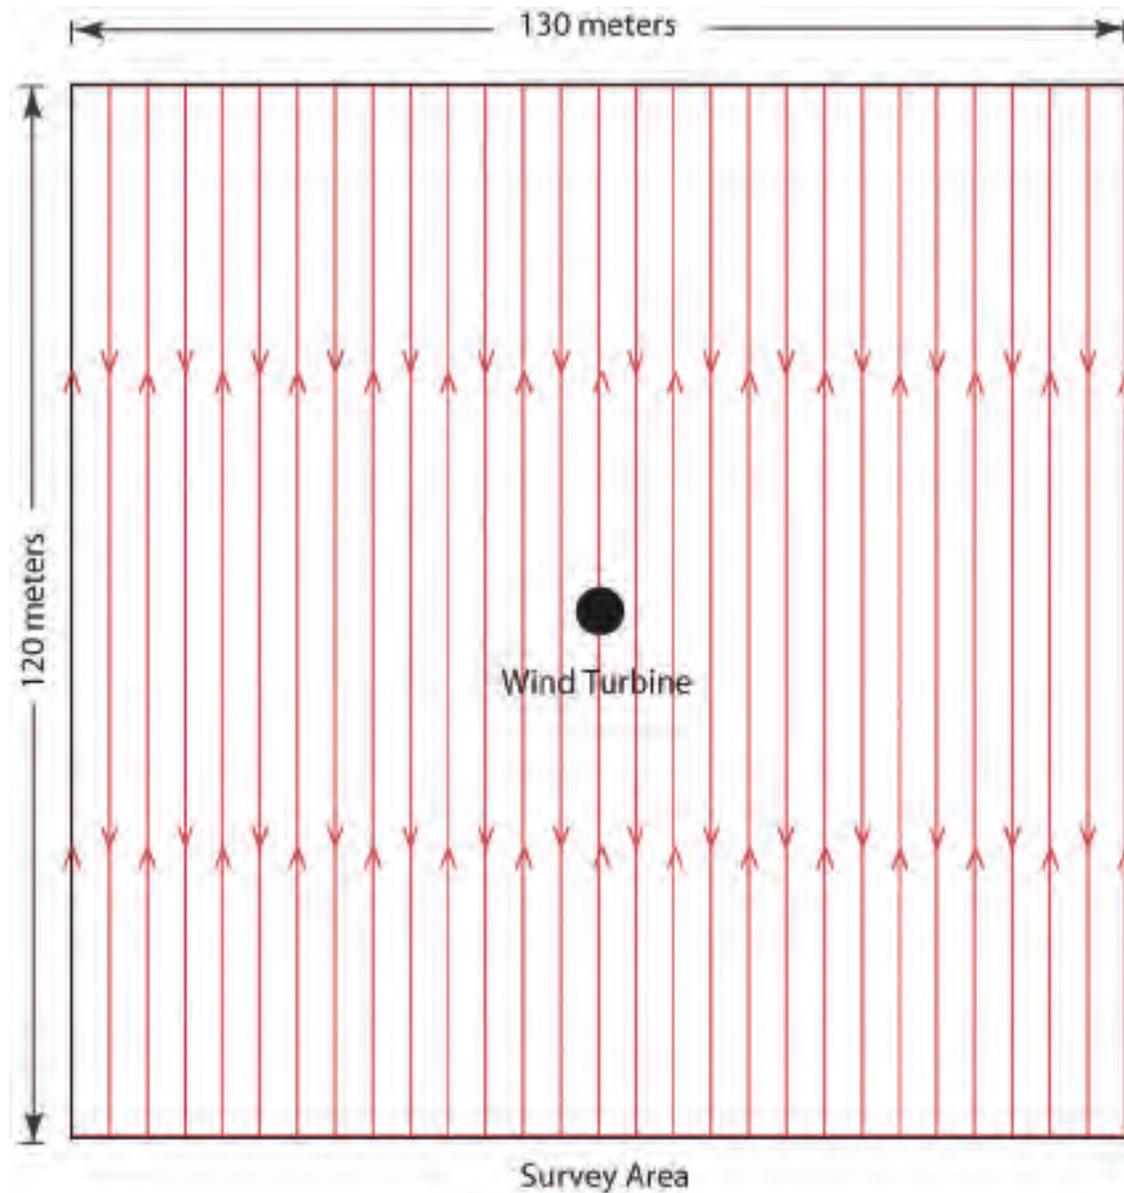
Figure 5. Schematic of the transect layout for carcass search surveys. Transects are spaced approximately 5 meters apart. The survey plot is oriented to maximize the searchable area. While walking each transect, the searcher used the unaided eye to conduct the survey, alternately scanning an area that extended for 2.5 m on either side of his/her track.

Searches were conducted at each turbine sampling plot every other day (i.e., typically Mondays, Wednesdays, Fridays) and started approximately 1 hour after sunrise to insure sufficient illumination for detecting potential collision victims. To reduce the chance of turbine plots regularly being surveyed at the same time of day, the order they were searched was alternated systematically on each survey day as was the starting transect at each turbine. While walking each transect, the searcher used the unaided eye to conduct the survey, alternately scanning an area that extended for 2.5 m on either side of his/her track.

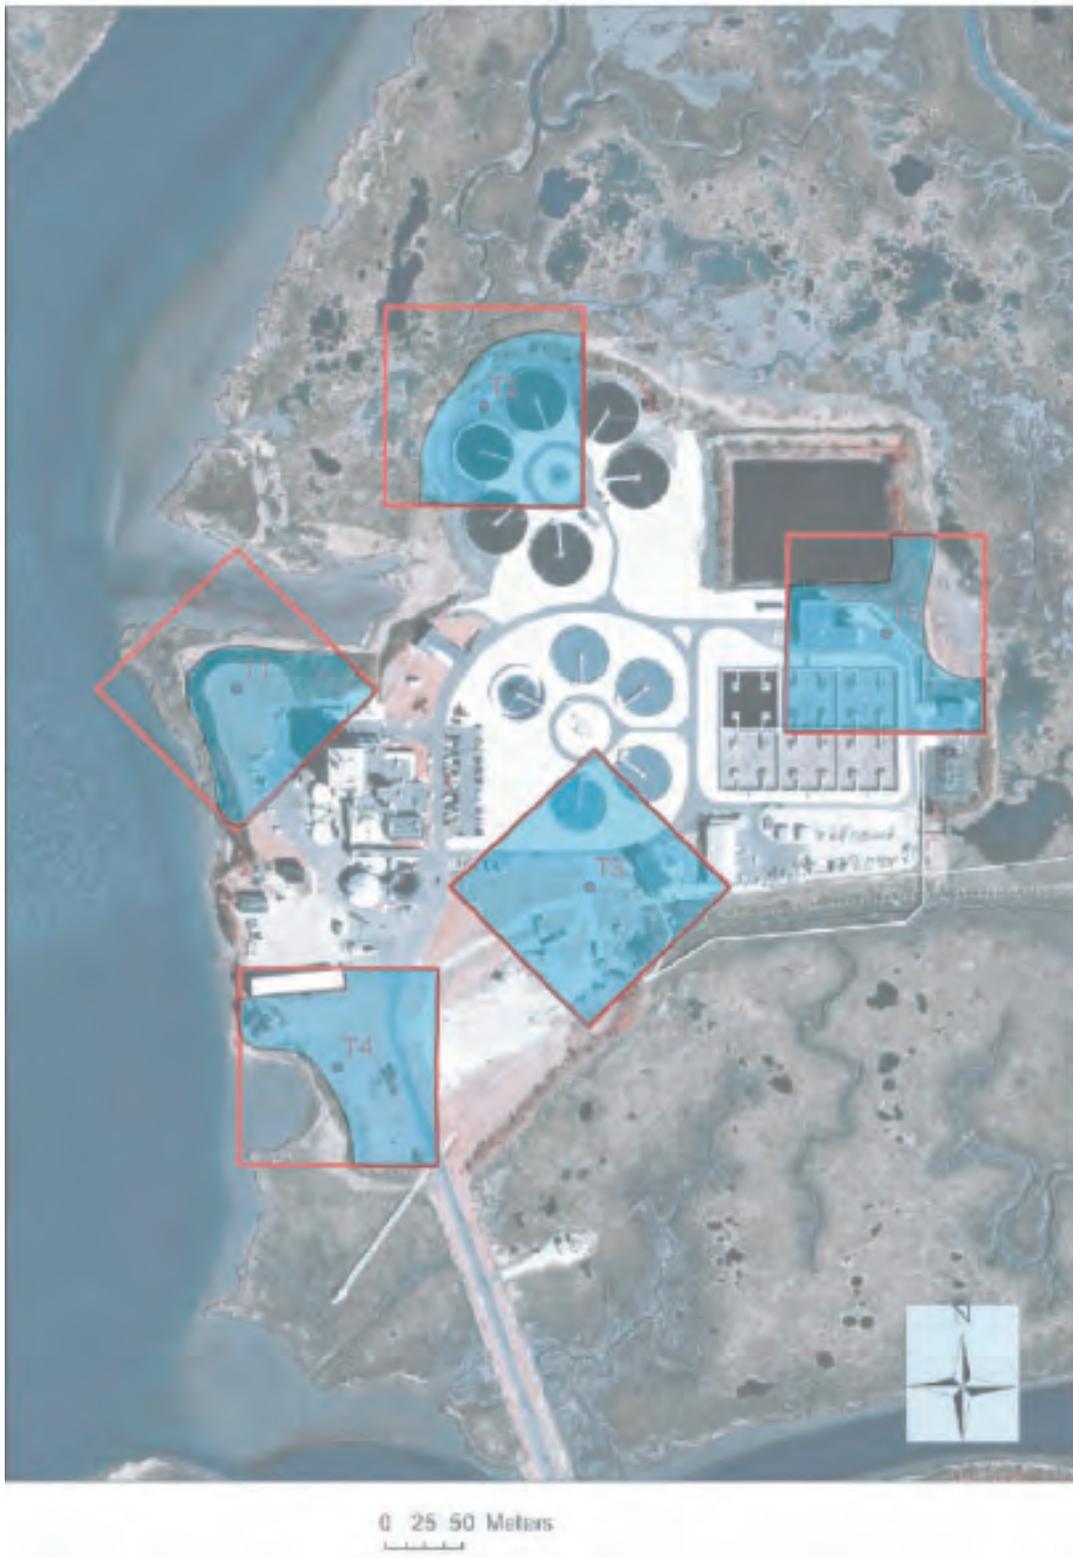
Figure 6. Atlantic City Utilities Authority (ACUA) study site showing actual survey areas (shaded in light blue) used during collision incident surveys. Low lying marsh areas within a turbine's search area were not surveyed because tidal inundation regularly prevented access to these sections. To some extent this was the case at all turbine sites except at turbine #3. If a building fell within the search area, rooftops were surveyed when accessible. Clarifying and mixing ponds, and other water bodies were also surveyed using walkways, gangways and dikes to gain access. Collision incident estimates will be corrected for the proportion of the total area around each turbine that was searched.

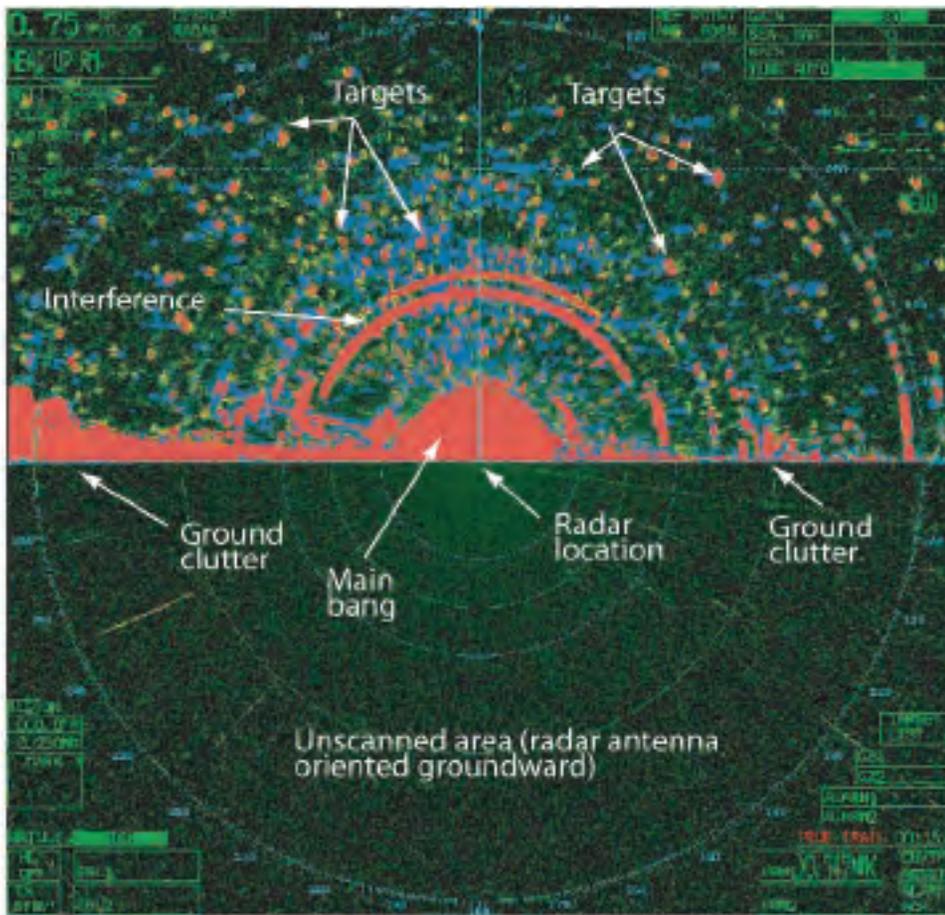
A

Figure 7. (A) Data images from vertically-oriented and (B) horizontally-oriented radars collected at the Atlantic City Utilities Authority (ACUA) study site on 31 August 2007 at ~2300 EST. Radar displays targets using an RGB color scale to represent 29 reflectance levels (i.e., amount of energy reflected by target).

Greens → Yellows → Reds = low → moderate → high reflectance values

Target tracking (shown in blue) can be used to estimate target velocity and flight direction. Circular areas of red at the center of each data image is referred to as the “main bang.” The main bang is an inherent property of all radars representing the radar’s noise range and thus occludes target detection in this region. Irregularly shaped red areas, referred to as ground clutter, are typically large, stationary features (e.g., buildings, turbines, marsh) in the radar’s field of view that reflect electromagnetic energy. Similar to the main bang region, these features occlude target detection.
